Royal Commission on the Pike River Coal Mine Tragedy

Volume 1

+ Overview

Date of Publication: October 2012

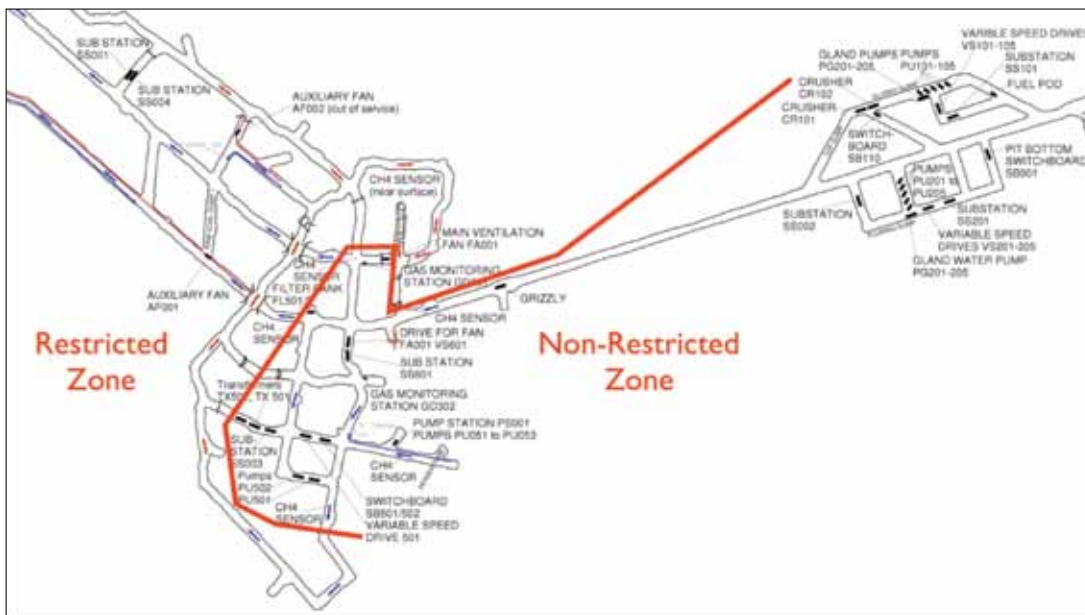
Figure 2: Boundary between the restricted and non-restricted zones⁶

Regulations require a gassy mine to have a restricted zone where all electrical equipment must be incapable of sparking an explosion. The dividing line at Pike River is shown below.

The non-restricted zone, as drawn, allowed unprotected electrical equipment to be located on the right-hand side of the line in most of pit bottom south. The zone was fixed without a risk assessment, after electrical equipment was

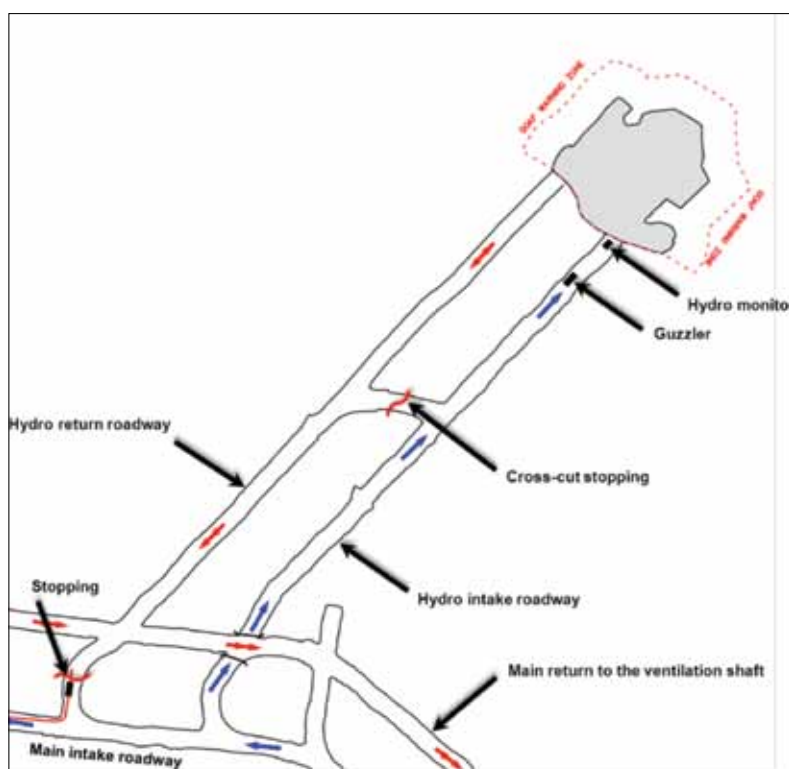
Figure 3: Diagrammatic outline of hydro panel⁷

Hydro mining started at Pike River in September 2010. This is an uncommon and specialised mining technique that uses a water jet to cut the coal face and requires expert design of the mining panel and equipment. Operators must be trained to follow a set cutting sequence and to direct the water jet to avoid the undue disturbance and release of methane. The hydro panel was developed as shown in this plan.

The water jet was mounted on the monitor, with an operator stationed at the guzzler. The goaf was unsupported and roof falls were expected. The intake of fresh air is represented by the blue arrows and the outflow of return air by the red arrows.
