Royal Commission on the Pike River Coal Mine Tragedy

Volume 1

+ Overview

Date of Publication: October 2012

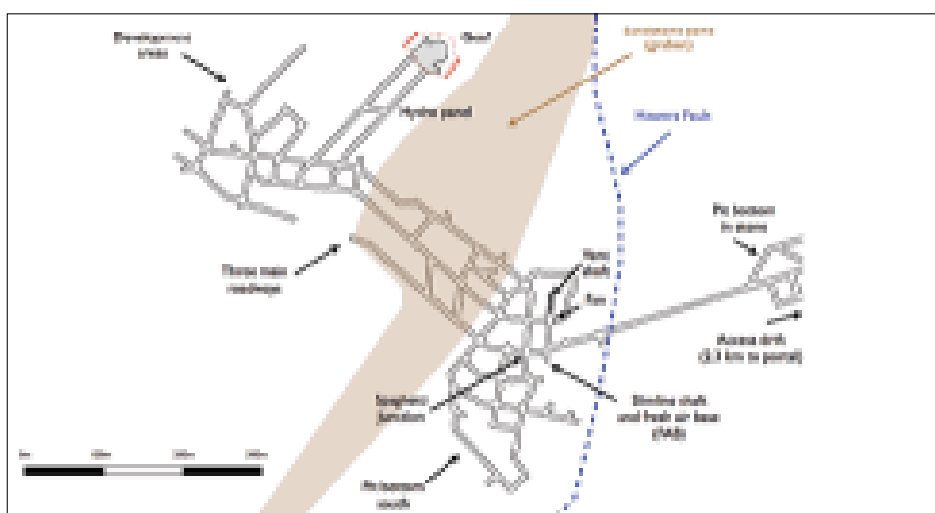
Figure 1: The mine plan as at November 2010²

There were two mine infrastructure areas (pit bottom in stone and pit bottom south), three main roadways, the hydro-mining panel and further development areas to the north-west. Spaghetti Junction was the meeting point of the drift and pit bottom, with two surface-to-mine shafts nearby – the main ventilation shaft, and the slimline shaft, at the bottom of which was a so-called fresh air base (FAB). Pike River was a small mine, still at an early stage of development.
